# Technical Bulletin

Document #: ETB0062

Models: 46-120MK2 / 46-240

## 46-SERIES FIRMWARE UPDATE V1.2

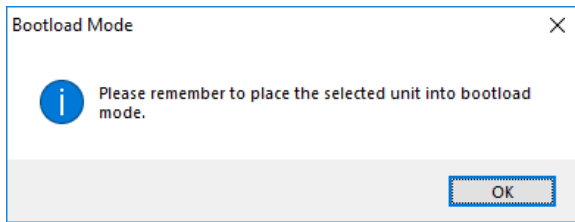
A dialog box will appear, with a reminder that the unit will need to be put into bootload mode, before the actual firmware update can take place:

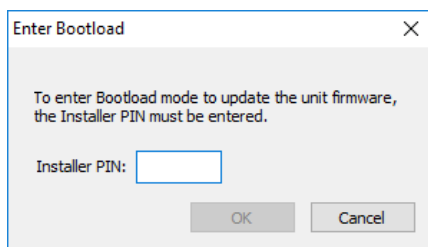
7. Click on the "Enter Bootload" button, and a dialog box will appear, prompting for the Installer PIN, to unlock the bootloader.

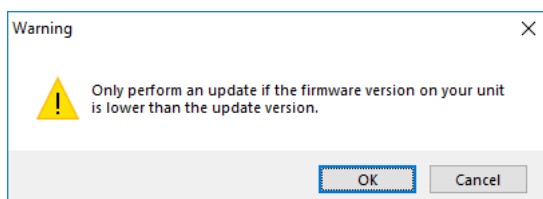
A warning message will appear:

This is the last opportunity to cancel the update. Clicking on the "OK" button, will start the update process.

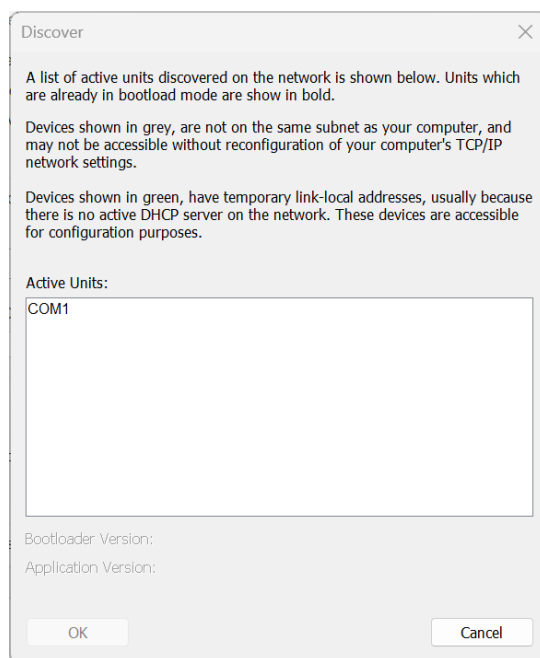
The process for upgrading the firmware, given above, can now be followed from Step 5 onwards. Upon clicking the "Discover..." button, instead of IP addresses being shown, a list of COM ports, on which Cloud 46-Series units have been detected, will be shown, after a few seconds. If there are a lot of COM ports on the laptop/PC, then this process may take a while to scan them:

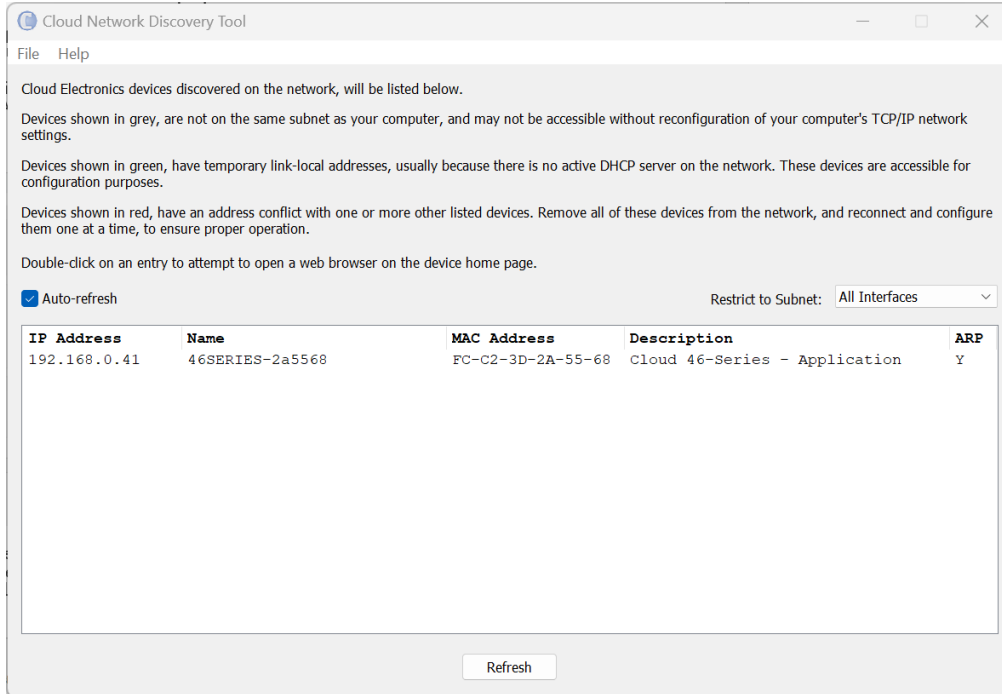
To access the new Web User Interface of the 46-Series, please download the **Cloud Network Discovery Tool** from the 46-120MK2, or 46-240 product pages on the Cloud Electronics website (<https://www.cloud.co.uk>). Once installed, this can be used to locate the 46-Series unit on the network.

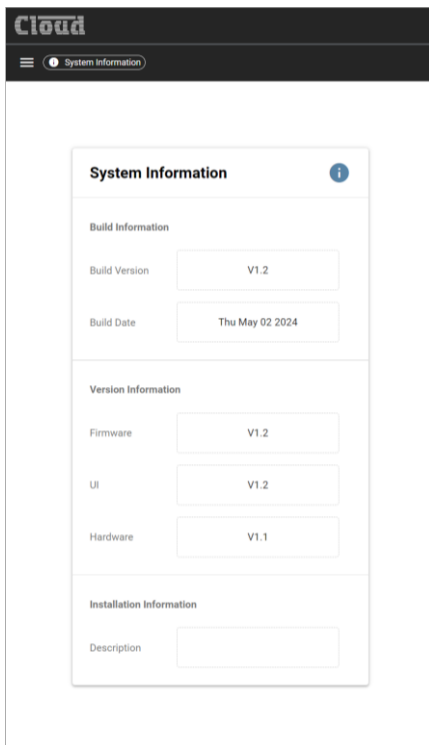
Double-click on the appropriate entry in the list, and the system default browser will be shown, opening automatically on the home page of the Web User Interface.

The menu icon at the top left of the header, can be used to open the menu, and select the **Login** option, to configure the settings. There are 3 default PIN-based access codes:
